St. Arnold Brewery

TRUEGRID with ¾" Crushed Limestone

TRUEGRID® Project Scorecard

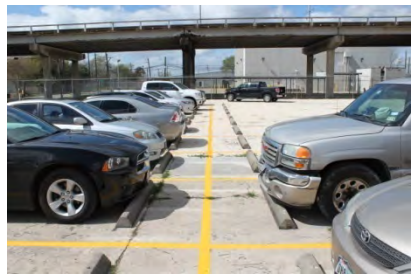
New TRUEGRID Side

Cracked concrete and contaminated soil were removed from Lot 1. After grading 6" of recycled road base was laid and compacted. The grid was installed and filled with 3/4" clean limestone. Parking stripes were painted for marking parking spots and remain very visible 18 months later without maintenance. Lot 2 required removal of broken asphalt and some dead grassy medians. The same procedure was followed as with Lot 1. No additional drainage or retention elements were added apart from the TRUEGRID system.
